Central Valley Regional Water Quality Control Board

***WET WEATHER SITE INSPECTION REPORT #3, RECOLOGY YUBA SUTTER LANDFILL,
YUBA COUNTY***

INSPECTION REPORT

INSPECTION DATE: 6 February 2015

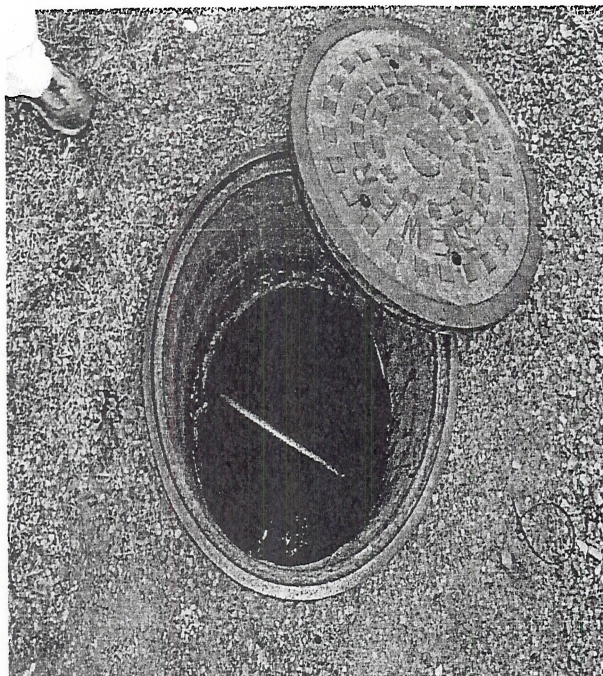
Photo 1: Point of onsite discharge to POTW.

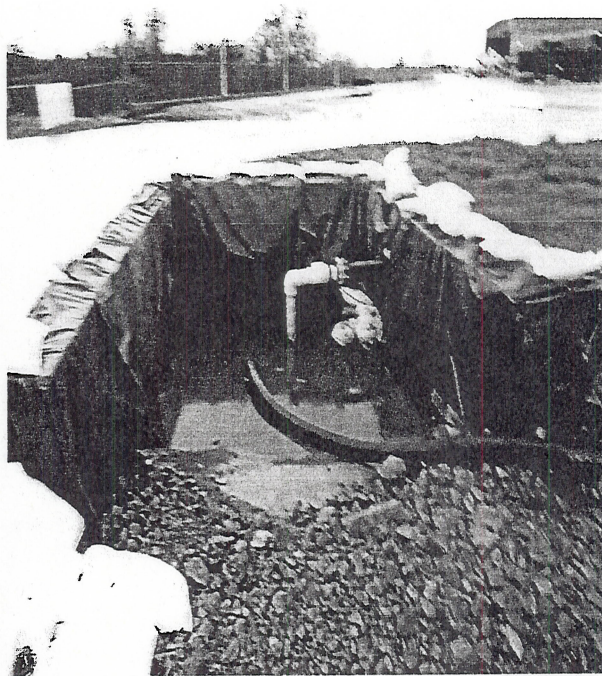
Photo 2: Eastern sump of southern compost area. Light rain during this inspection and sump appeared to be able to keep up.

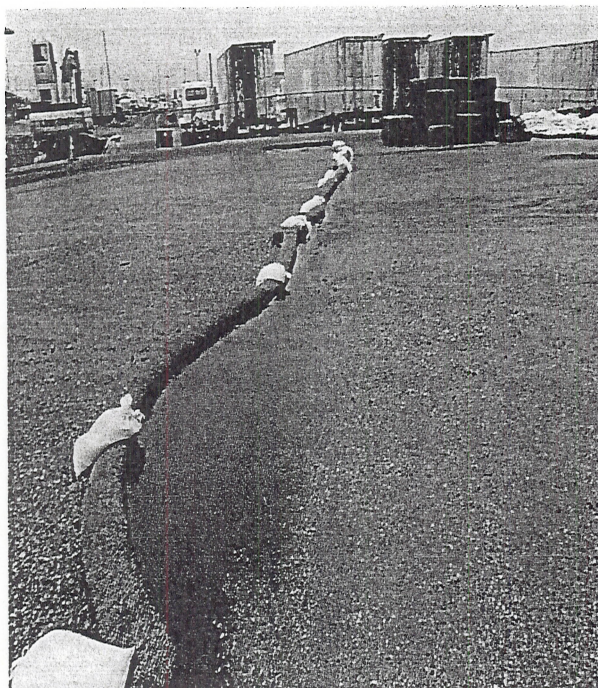
The only area of concern that staff noted during this inspection was ponding leachate on the compost pad. In general, this condition was exacerbated by BMPs retaining runoff (Photo's 3 and 5) and improper grading at the toe of the compost pad (Photo 7). The Discharger should work toward

Photo 3: BMPs placed in December 2014. Note slight ponding of leachate. Ponding on the cover is a violation of the CAO and WDR.

alleviating these deficiencies during precipitation events to keep leachate from ponding. The Discharger should identify ponding as a priority maintenance item.

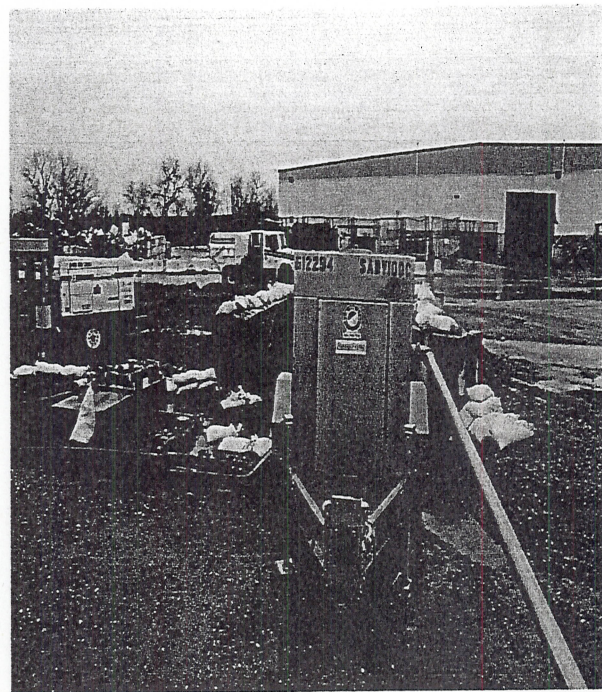
Photo 4: Backup pumps and generators located at the western sump of the southern compost area.

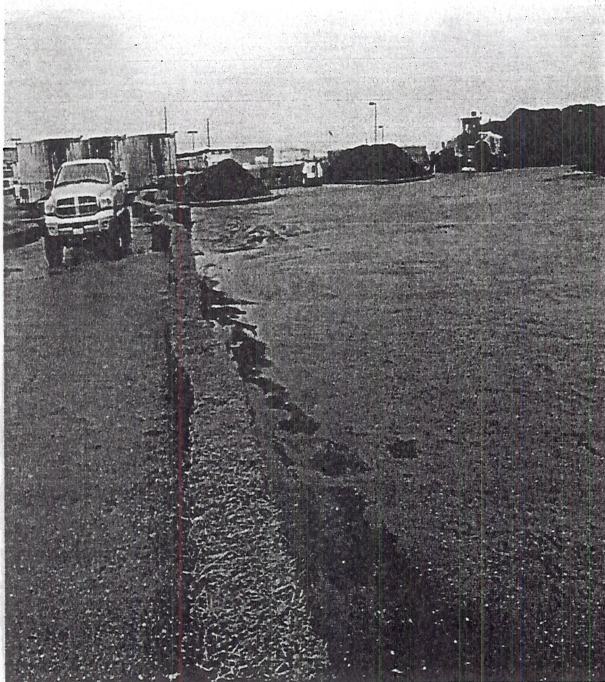
Photo 5: Ponding behind BMPs installed during the December 2014 storm events. Ponding on cover is a violation of the CAO and WDRs.

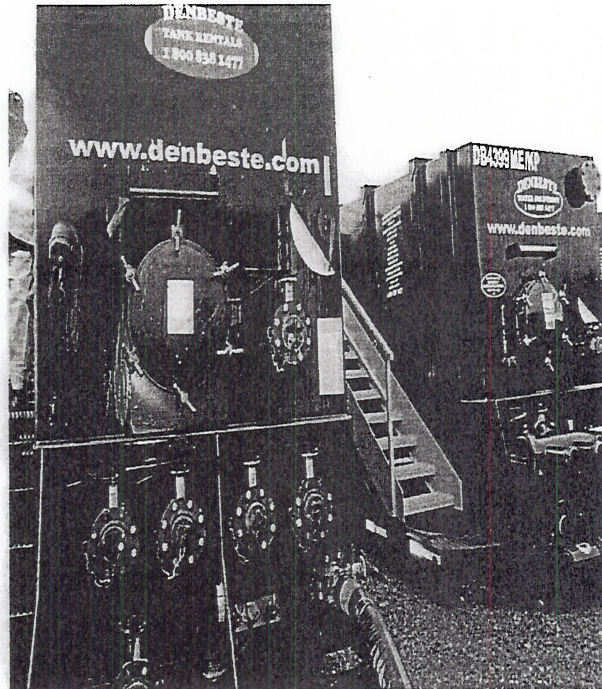
Photo 6: Northern tank farm with empty tanks indicating capacity during this site inspection.

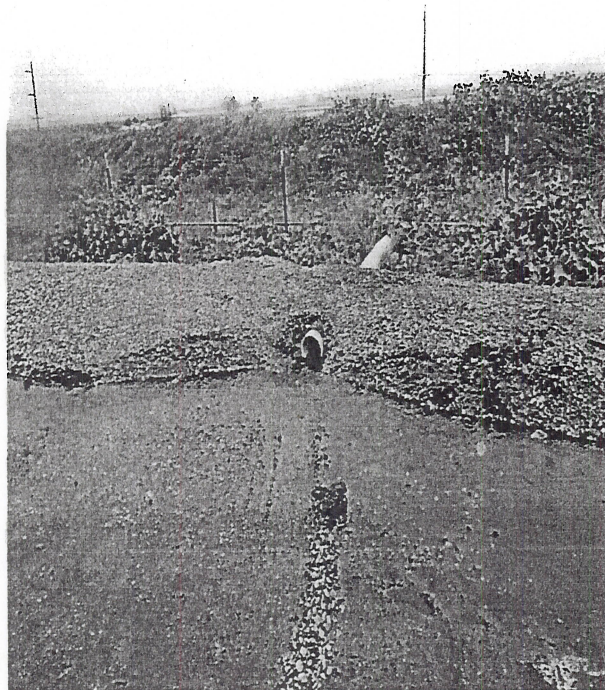
Photo 7: Compost pad draining through 6-inch diameter lateral to 18-inch diameter header pipe to northern sumps.

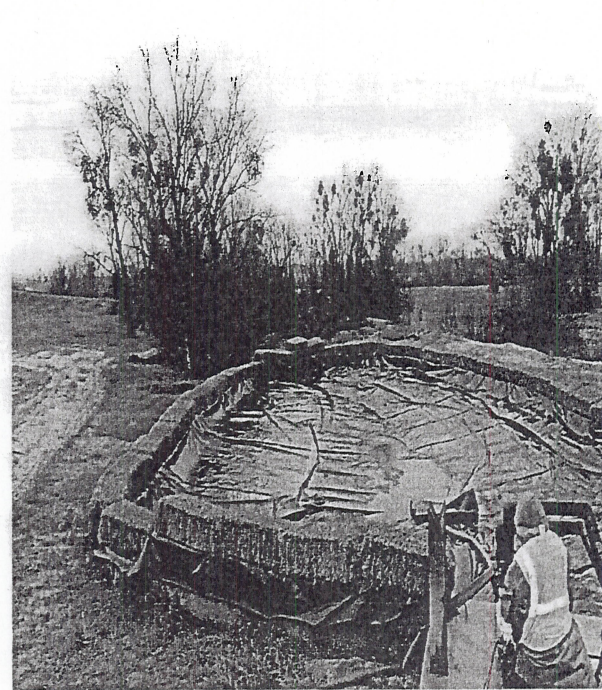
Photo 8: Plastic lined basin erected as emergency catchment due to previous discharges of leachate. This is not an approved containment system or part of the collection system design.
